# DAM INSPECTION CHECKLIST POSSUM POINT POWER STATION POND ABC

INSPECTION DATE: MARCH 1, 2016

INSPECTED BY: K. ACREE

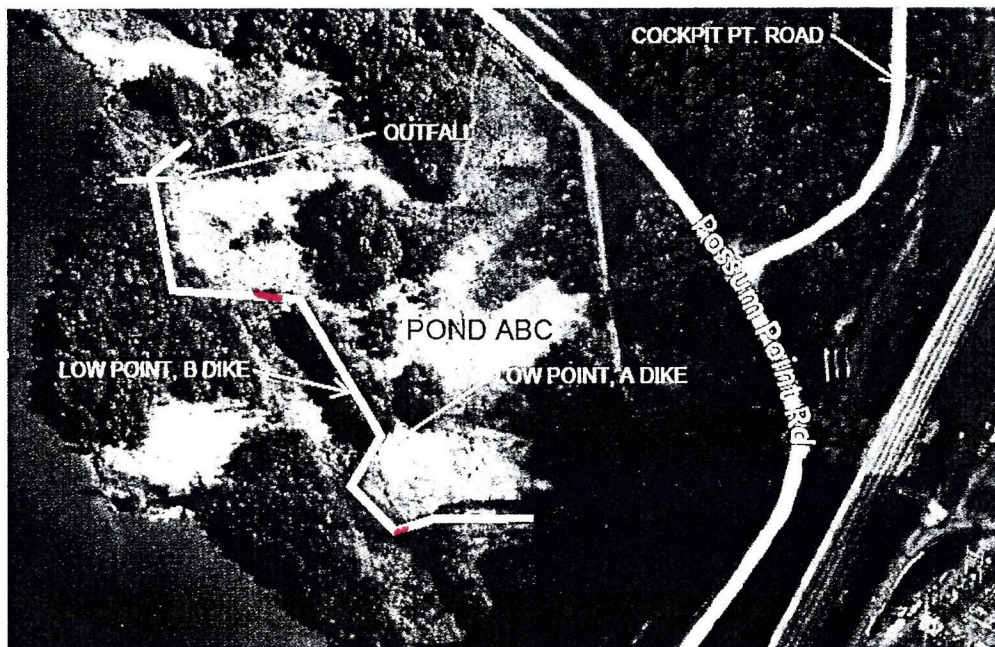
Location/ Condition	(y/n)	Change (y/n)	Comments
Low Point, A dike*			
Flow	N	N	913 → SAND BAGS AND RIPRAP ARE IN PLACE. NO STANDING WATER AGAINST SAND BAGS.
Erosion	N	N	SEVERAL SAND BAGS ARE RIPPED.
Low Point, B dike*			
Flow	N	N	915 → SAND BAGS ARE IN PLACE AND THERE IS NO STANDING WATER AGAINST SAND BAGS.
Erosion	N	N	A FEW SAND BAGS ARE RIPPED.
Outfall water surface El. (top of stoplogs to water)			924 → NO STANDING WATER AGAINST WEIR, NO FLOW THROUGH WEIR, AND THE WEIR APPEARS TO BE <u>DRY</u> .

**Additional Comments (Note any changes observed along the embankment crest or downstream slope observed from the crest.):** LOW POINT, C DIKE → 921 → SAND BAGS ARE IN PLACE, NO STANDING WATER AGAINST SAND BAGS, AND SEVERAL SAND BAGS ARE RIPPED.

→ STANDING WATER AT INSIDE TOE OF POND A EMBANKMENT (TYPICAL FOR POND A B/C)

→ STANDING WATER AT TOP OF EMBANKMENT OF POND A, B, & C. (NOTED ON FIGURE BELOW)
